# INSPECTOR CLUSEAU'S HOME INSPECTION SERVICE

## INSPECTION REPORT

1234 Main St.  
Loudon TN 37774

08/28/2018 9:00AM

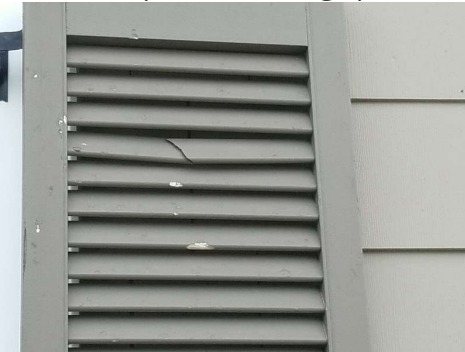
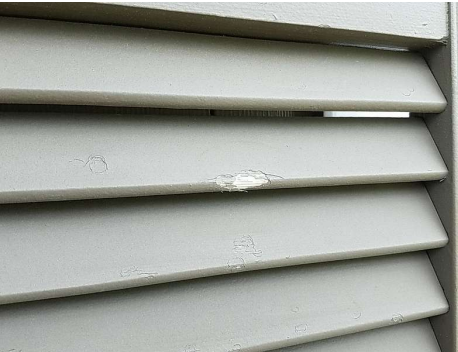
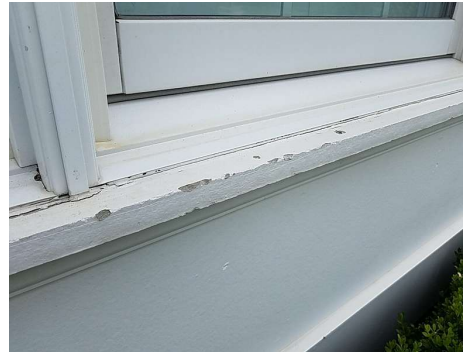
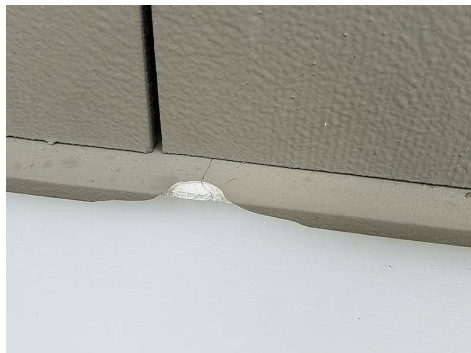
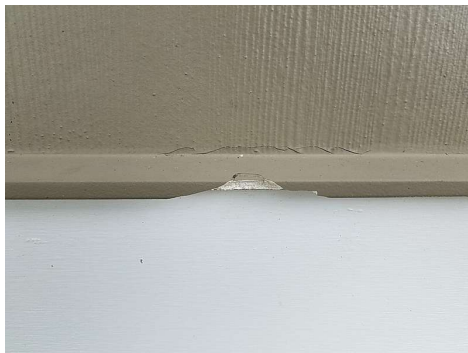
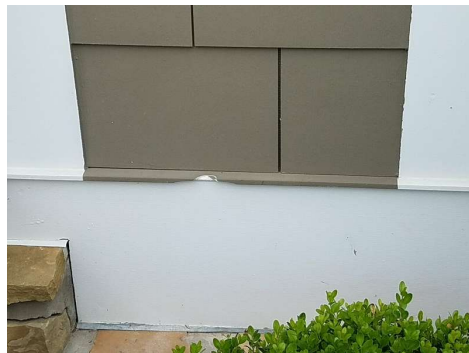
There are blemishes in the surface at several areas around the home (primarily on the front wall - west side facing directional weather). The blemishes are in the surface of the shutters and trim pieces. Wood surfaces should be repaired and painted to discourage deterioration. The blemishes on the trim pieces are mainly aesthetic and can be replaced as desired.

Contact a qualified siding specialist.

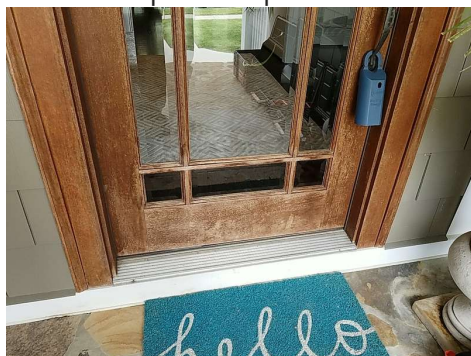
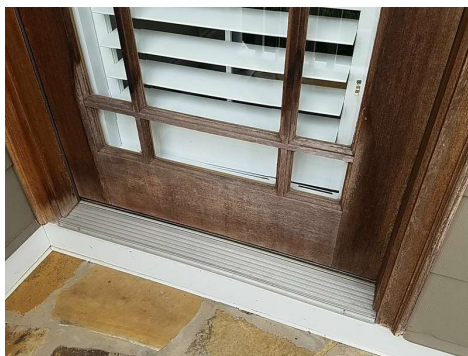
#### 2.4.1 Exterior Doors

### WEAK STAIN ON DOORS

The stain is weak on the front exterior doors. This is normal to occur, especially for doors facing west and exposed to sunlight. The doors can be re-stained as desired.

Contact a qualified painter.

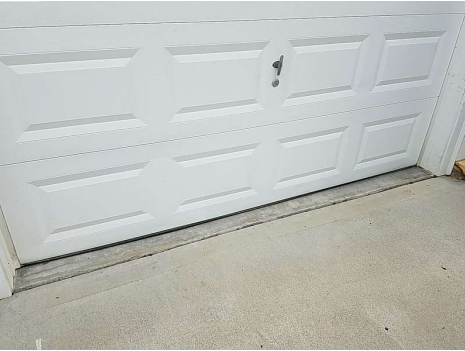
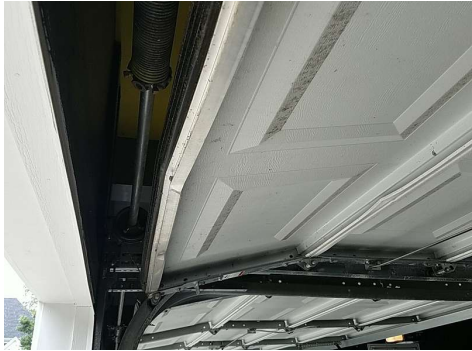
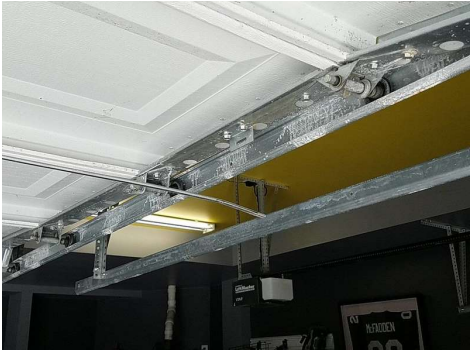
**DOOR PANEL BENT AND LOCK ARM IS LOOSE**

The right hand garage door is bent (bottom panel). This does not affect functionality of the door. The panel can be replaced as desired.

Contact a qualified garage door contractor.

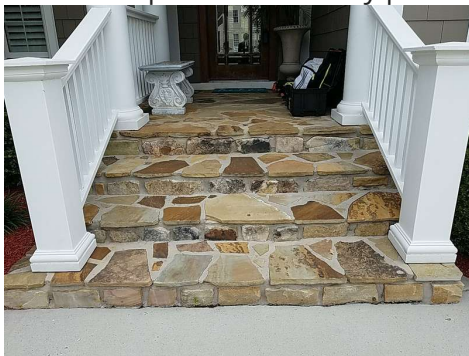
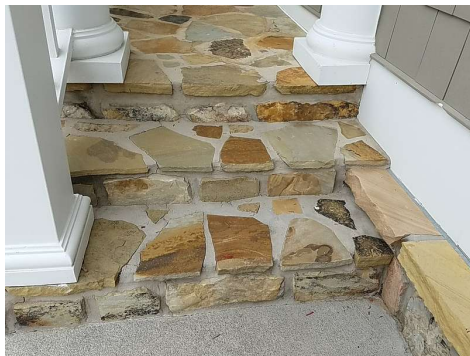
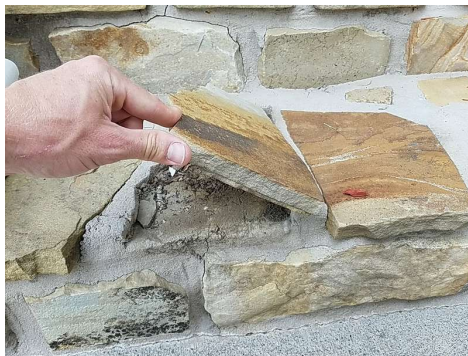
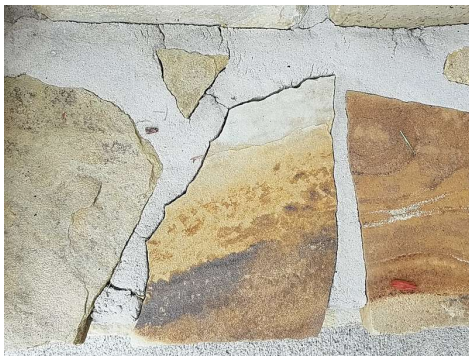
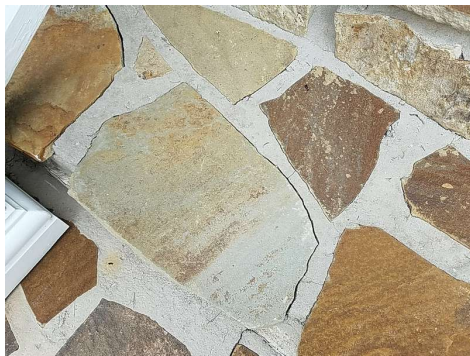
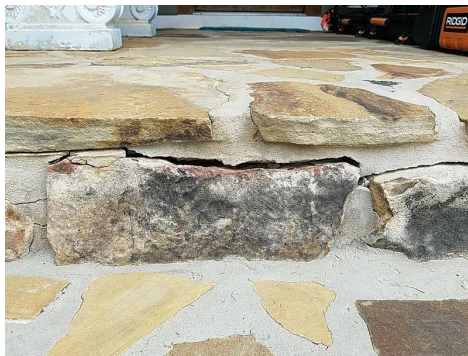
Some of the stones are loose at the porches on the front of the home. In addition, there are cracks in the mortar between the stones at various locations. All loose stones should be properly secured and any open joints in the mortar should be sealed to discourage further deterioration.

Contact a qualified masonry professional.

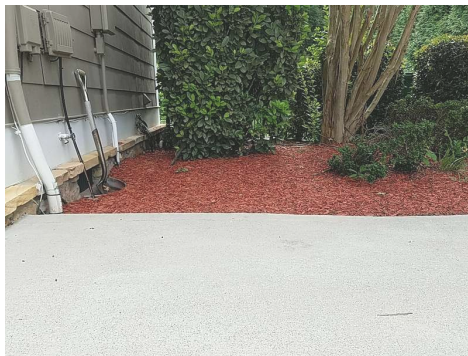
## 4.4.1 Grading and Drainage

**NEGATIVE GRADING**

Areas of the soil do not maintain proper slope away from the foundation. This could allow surface water to flow towards the foundation. All areas of the soil around the home should slope away from the foundation to encourage proper drainage away from the structure. If proper grading cannot be achieved, alternative means of drainage may be necessary (surface drain, french drain, etc.).

Contact a qualified grading contractor.

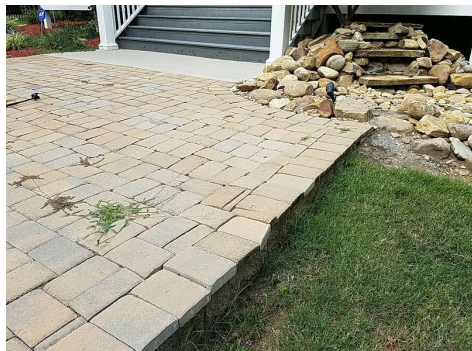
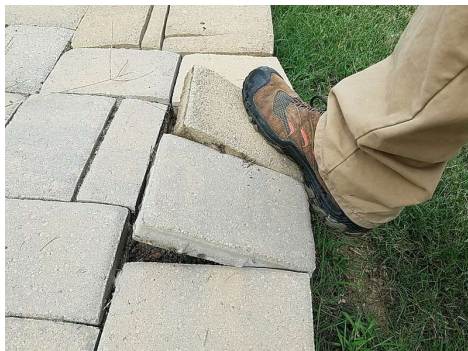
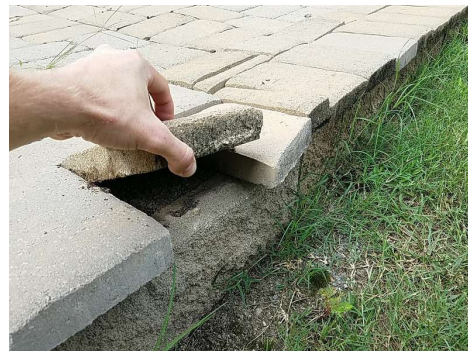
## 4.5.1 Patio

**LOOSE PAVERS**

Some of the pavers are loose along the edge of the patio. This is a potential trip hazard. I recommend all pavers be properly secured.

Contact a qualified general contractor.

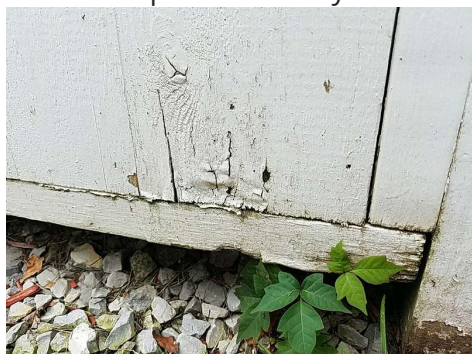
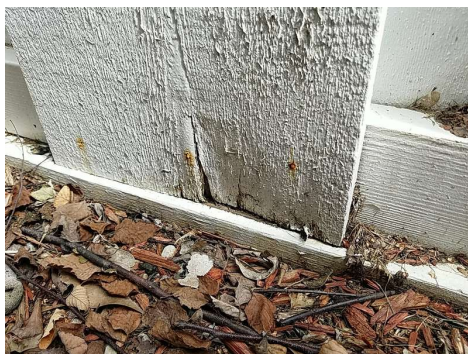
## 4.7.1 Fence

**DAMAGE TO FENCE BOARDS**

Some of the boards are beginning to rot on the privacy fence around the HVAC equipment. The boards can be repaired or replaced as necessary.

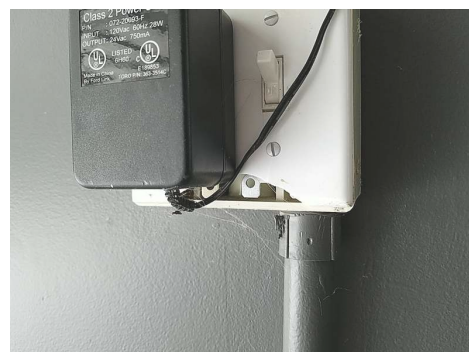
### 5.5.1 Fixtures

#### **COVER PLATES DAMAGED**

Cracked / broken cover plates were observed on the electrical fixtures. NOTE: I recommend replacing damaged covers.

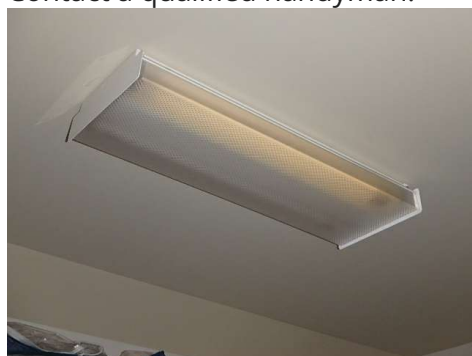
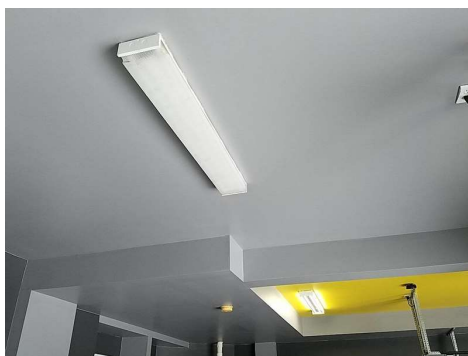
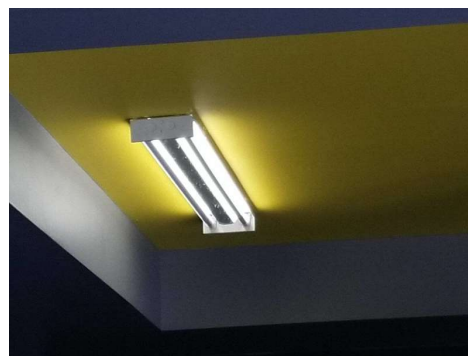
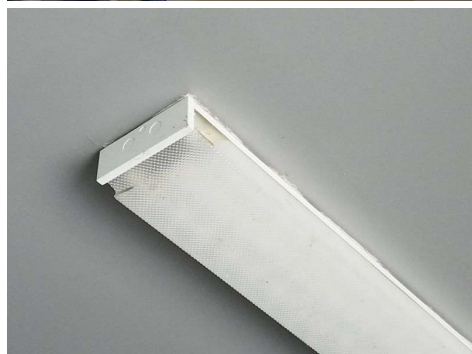
The fluorescent lights in the guest bedroom closet and garage are not working. I suspect the bulb or the ballast is bad and should be replaced.

In addition, the cover has been removed from one of the lights in the garage and the cover is broken on the other light in the garage. The covers can be replaced.

Contact a qualified handyman.

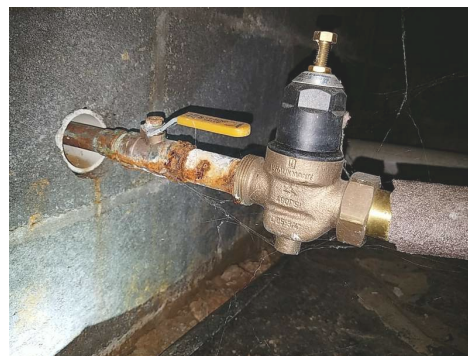
### CORROSION ON PIPING

There is corrosion on the water piping at the listed location. The affected pipe should be replaced to ensure prevent undetected leaks.

Contact a qualified plumbing contractor.

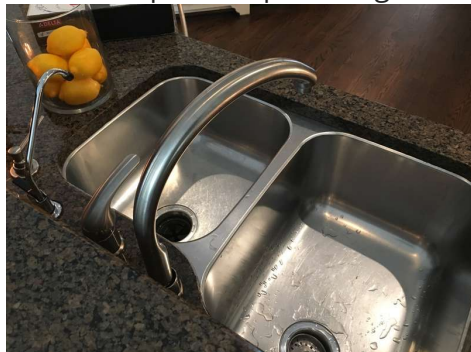
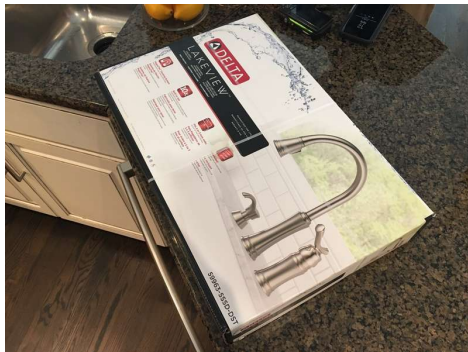
#### 7.5.1 Kitchen Sink

### FAUCET TO BE REPLACED

The kitchen sink faucet is broken. A new faucet is intended to be installed prior to closing.

Contact a qualified plumbing contractor.

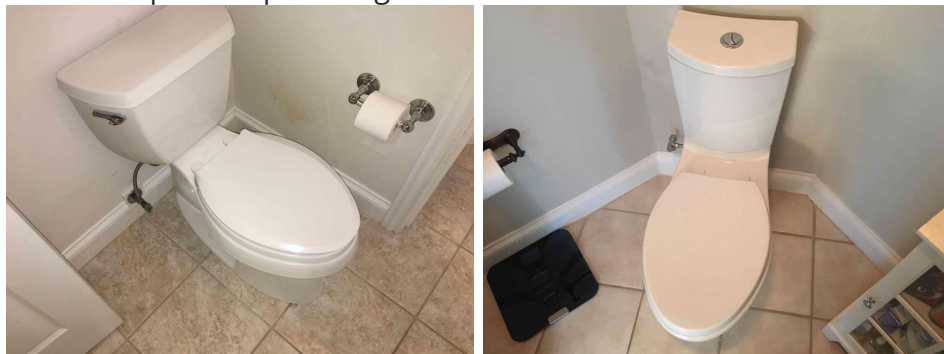
## 7.6.1 Bathrooms

**TOILET LOOSE / NOT SECURED**

The toilet is not secured tightly to the floor at the listed location. This raises potential for leaks at the seal. Necessary repairs should be made to secure the toilet and ensure there are no leaks or underlying concerns.

Contact a qualified plumbing contractor.

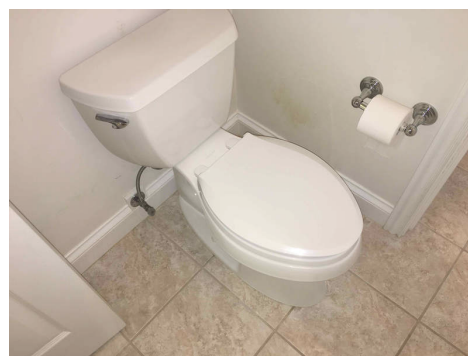
## 7.6.2 Bathrooms

**TOILET - WATER RUNS**

The water continuously runs at the toilet at the listed location. The internal components will need to be repaired / replaced.

Contact a qualified plumbing contractor.

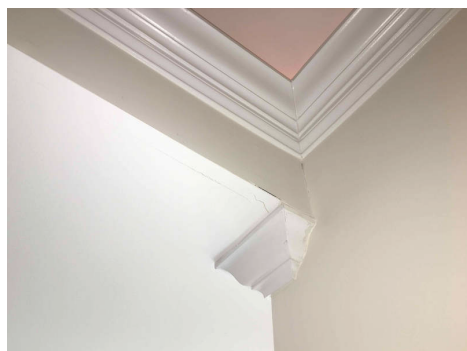
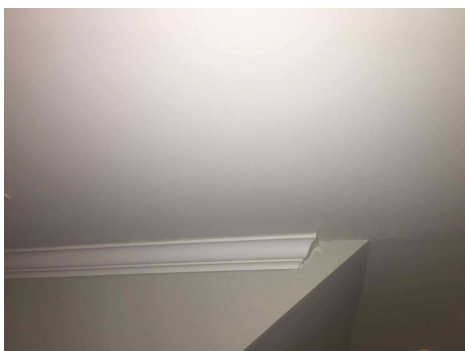
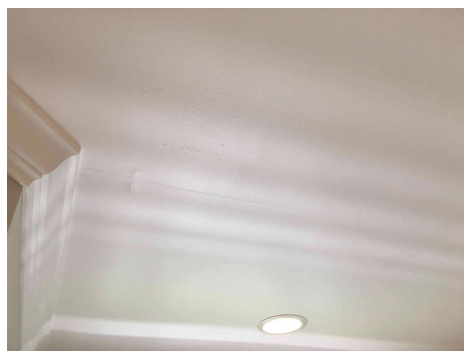
#### Walls and Ceilings: Settlement Cracks, Nail Pops, and/or Loose Tape Joints

There were settlement cracks, nail pops, and loose tape joints in the drywall at various walls and ceilings. The cracks, loose tape joints, and nail pops, are common to occur due to normal settling and/or to the expansion and contraction that occurs when heating and cooling the home.

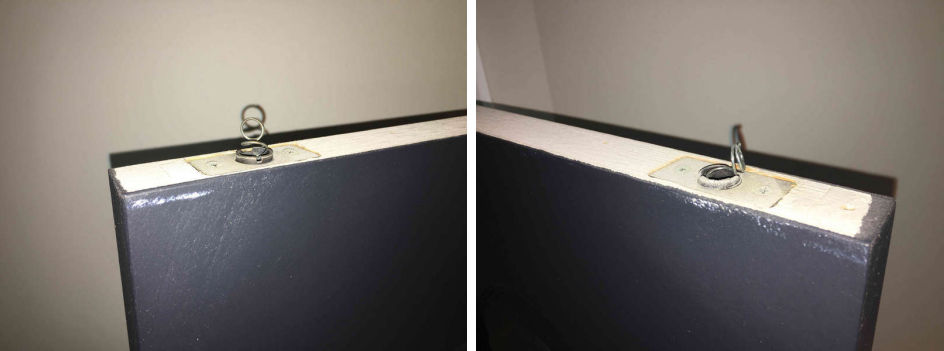
BALL CATCH BROKEN

The ball hinge is broken on the door in the master bathroom. The hinge will need to be repaired / replaced.

Contact a qualified door repair/installation contractor.

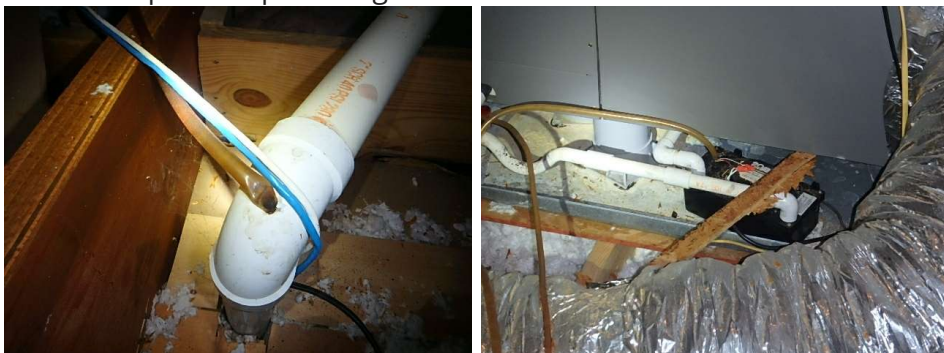
The condensate drain tube is connected to the plumbing vent pipe in the attic. The tube is kinked where connected into the vent pipe, which raises concern for the line to clog and crack. In addition, the drain tube does not have a proper fitting where attached to the vent pipe.

Contact a reputable plumbing company to make necessary repairs to the piping for best functionality and to prevent future concern.

Contact a qualified plumbing contractor.

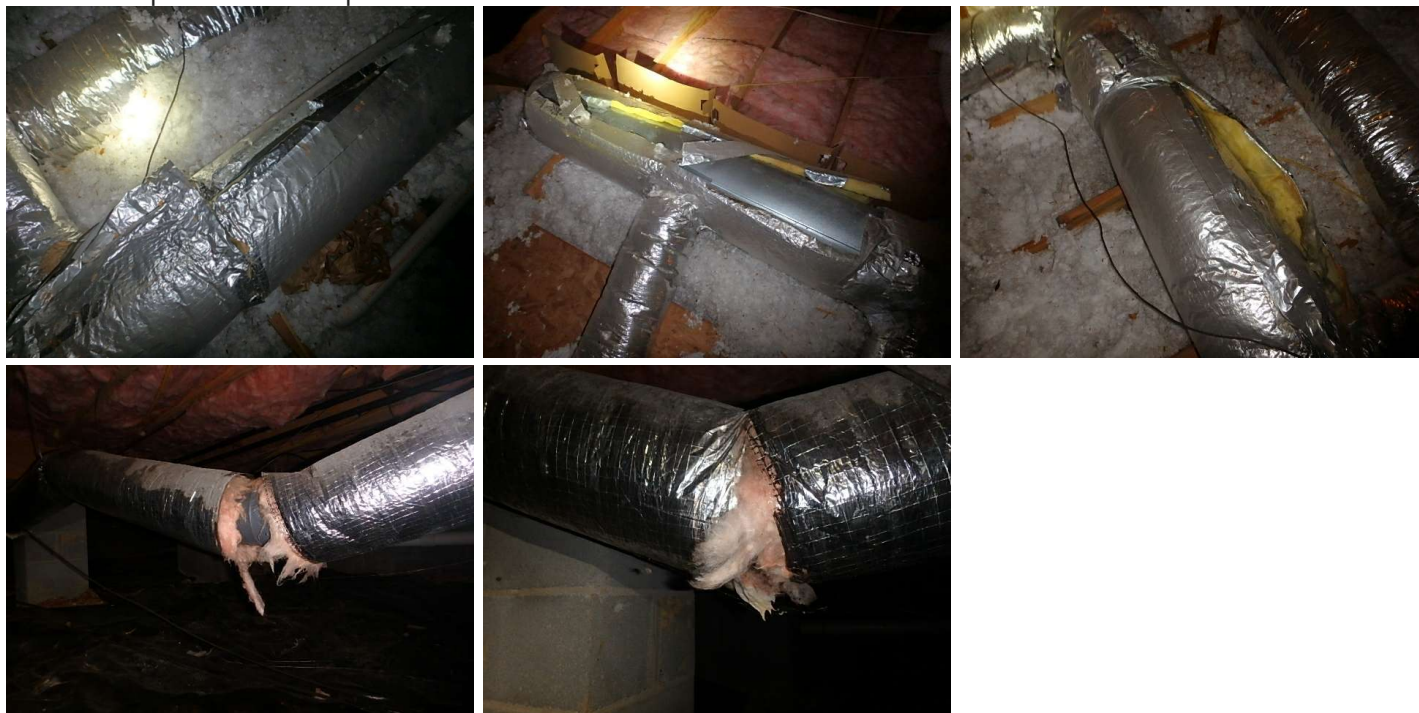
9.3.1 Ducts

### DUCT INSULATION IS LOOSE / TORN

The insulation is loose / torn on sections of the air ducts at the listed locations. The insulation on the ducts should be repaired.

Contact a qualified HVAC professional.

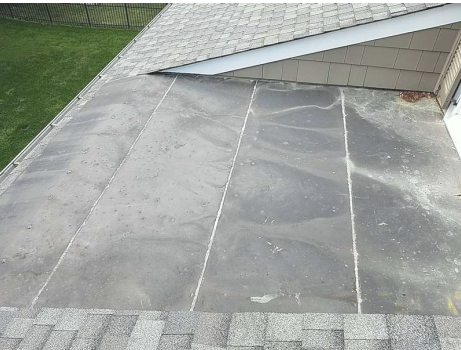
The metal roof surface at the rear is in overall good functional condition. There is hail damage in the surface (dents). The dents do not affect functionality.

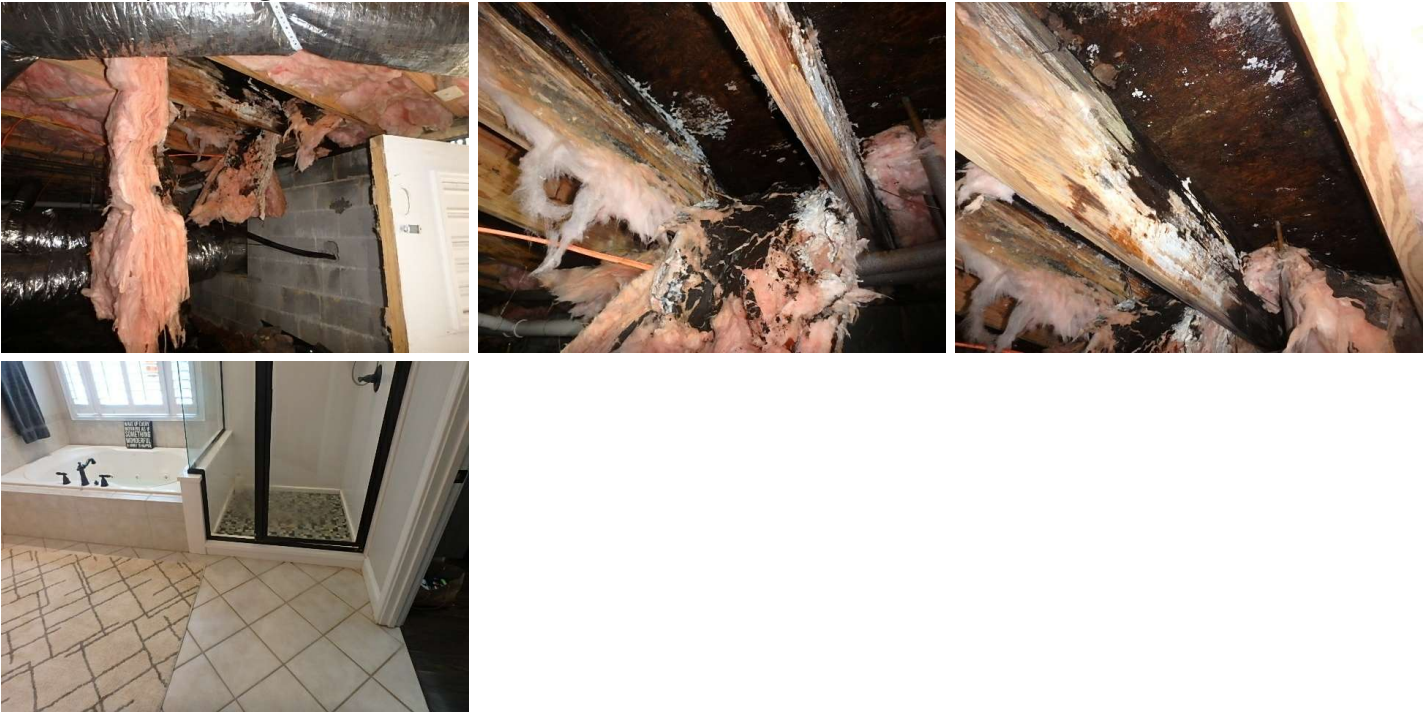
12.3.1 Framing

DAMAGED FRAMING

Contact a qualified general contractor.
