# INSPECTOR CLUSEAU'S HOME INSPECTION SERVICE

## INSPECTION REPORT

1234 Main St.  
Loudon TN 37774

08/28/2018 9:00AM

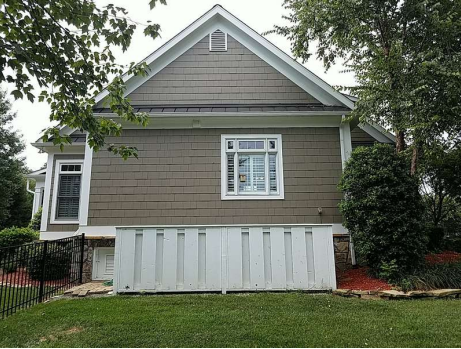
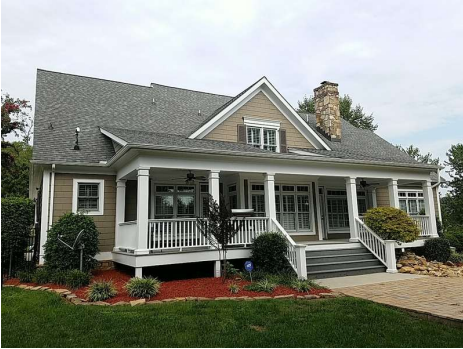
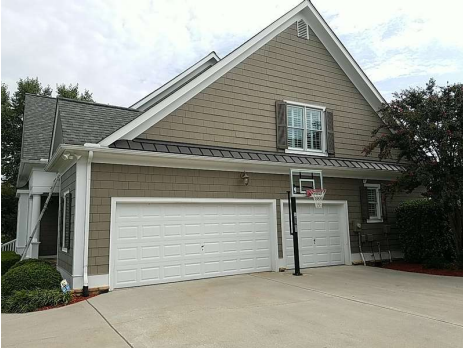
There are blemishes in the surface at several areas around the home (primarily on the front wall - west side facing directional weather). The blemishes are in the surface of the shutters and trim pieces. Wood surfaces should be repaired and painted to discourage deterioration. The blemishes on the trim pieces are mainly aesthetic and can be replaced as desired.

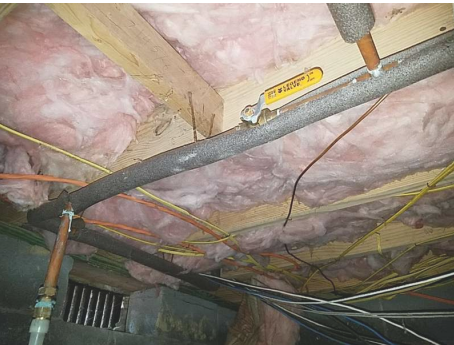
The water softener system in the garage is no longer connected to the plumbing system and is not in service. Consult with the owner to inquire if the system is intended to be removed prior to closing.

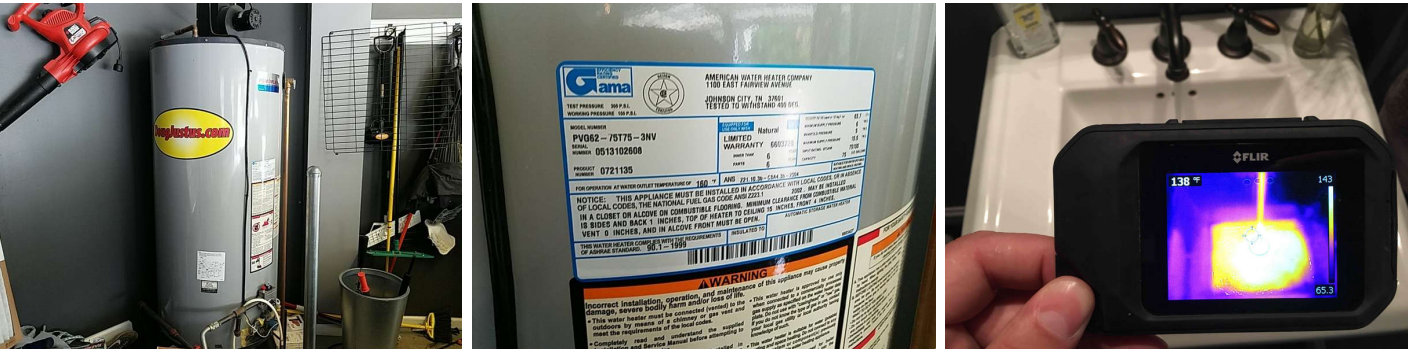
Energy Source: Gas, Gallons: 75, Nearing Average Life Expectancy, Age: 12-14

Water Heater: Nearing or Past Average Life Expectancy

The unit is nearing or has exceeded average life expectancy.

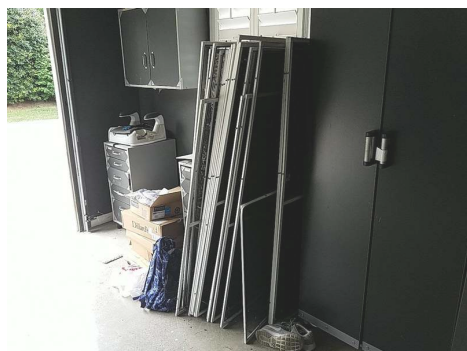
There are no screens installed on various windows. NOTE: the screens are installed in the garage.

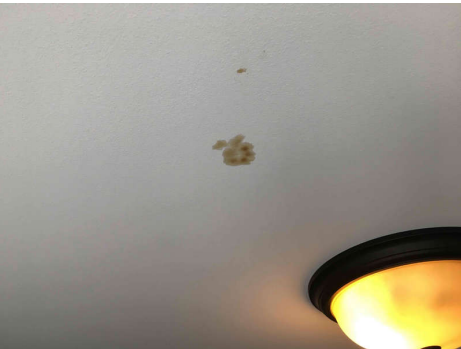
Upper Level Bedroom

There is a stain on the ceiling in the rear guest bedroom. This appears to be a surface stain and is not an indication of any previous leak or concern. The stain can be cleaned / removed and the ceiling re-painted as necessary.

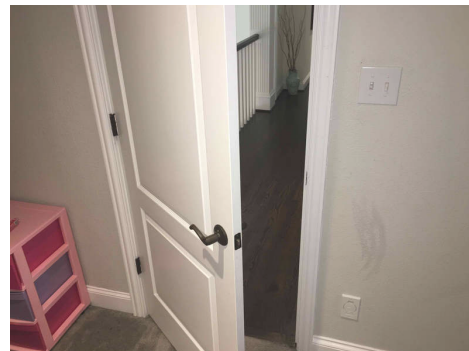
## 8.5.1 Floors

**CARPET STAINS**

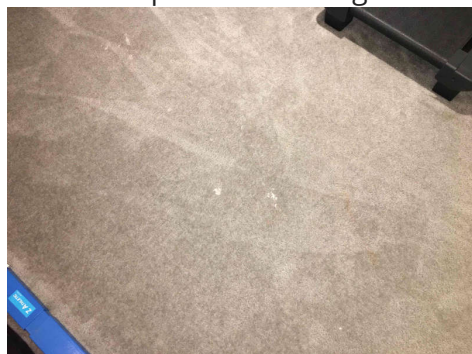
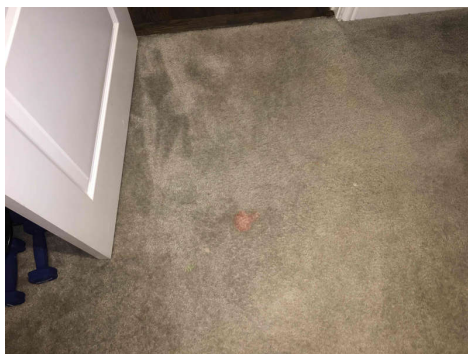
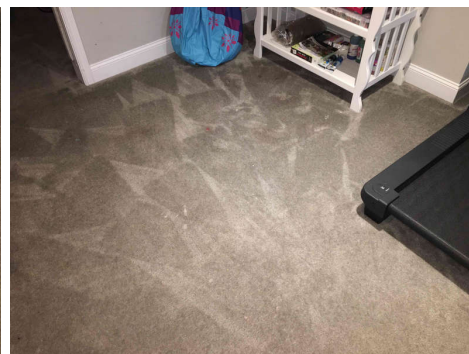
## 8.7.1 Countertops &amp; Cabinets

**COUNTER TOP NOT SECURED**

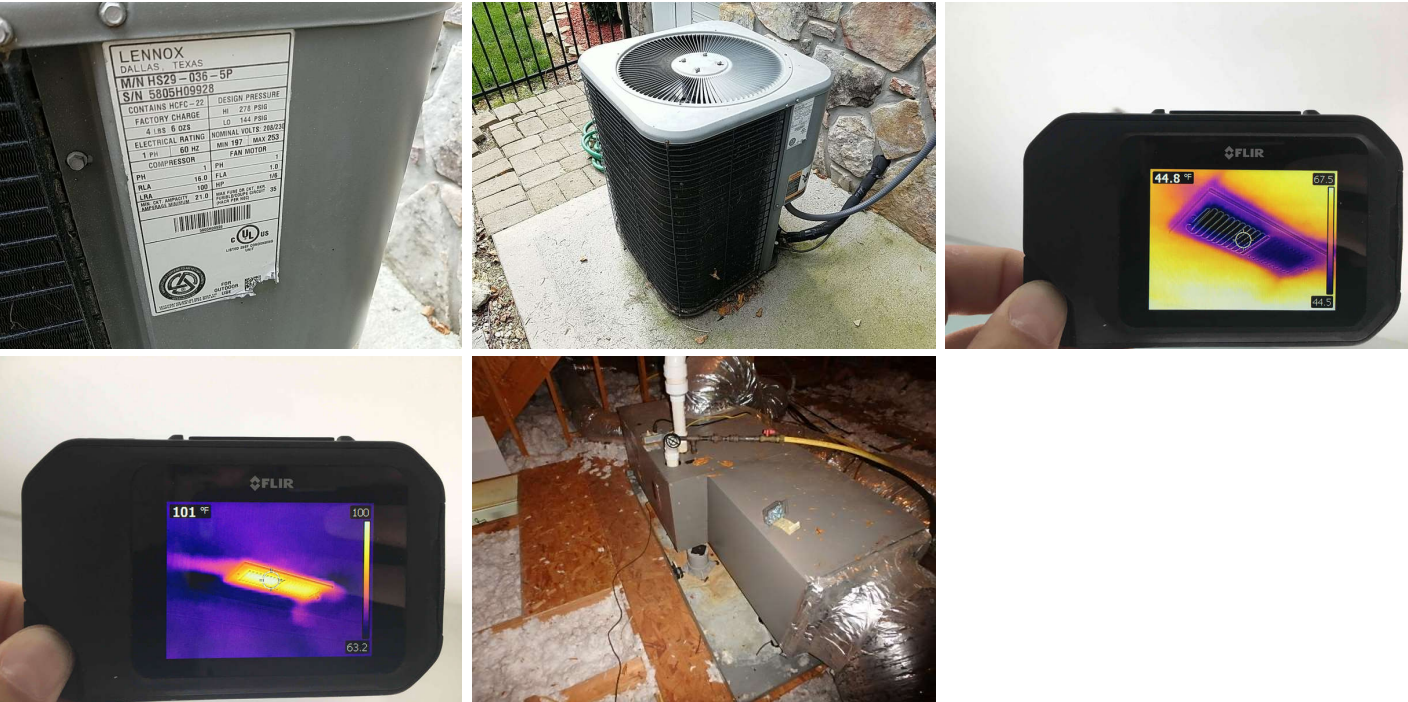
**Compressor:** Brand: Lennox / **Age (Years):** 12-13 / **Tons:** 3

Central System: Component Nearing or Exceeded Life Expectancy

Common life expectancy for most HVAC systems and components is 10-15 years. There are components present that are nearing or have past the average service life. Notable deficiencies will be listed in this report. I recommend obtaining a home warranty for all components that are nearing or have past their average life along with budgeting for repairs or replacement.

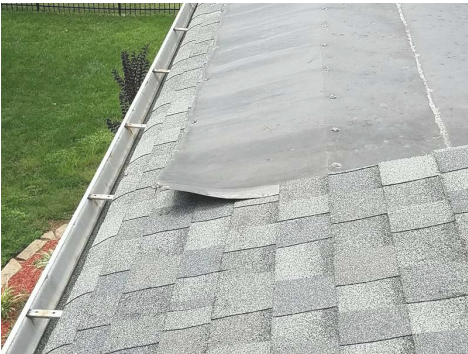
10.5.1 Roof Drainage Systems

SIGNS OF OVERFLOW

Recommendation

Contact a qualified gutter contractor

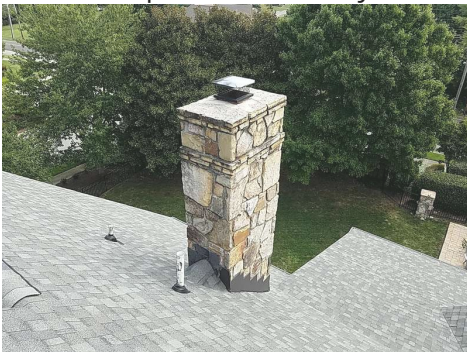
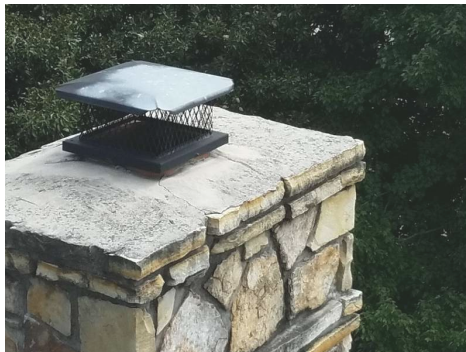
The open joints in the mortar on the chimney should be sealed to discourage water entry and further deterioration.

Contact a qualified chimney contractor.

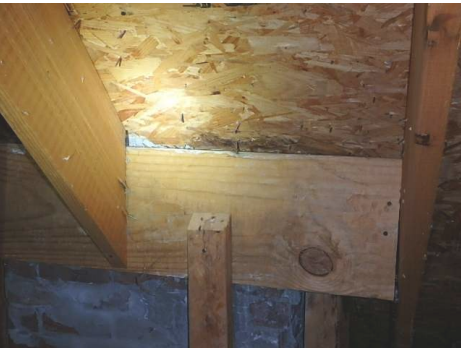
General: Signs of Previous Leak

There were signs of previous leaks in the attic. All accessible areas were tested with a moisture meter and no moisture was detected unless otherwise specified in this report.

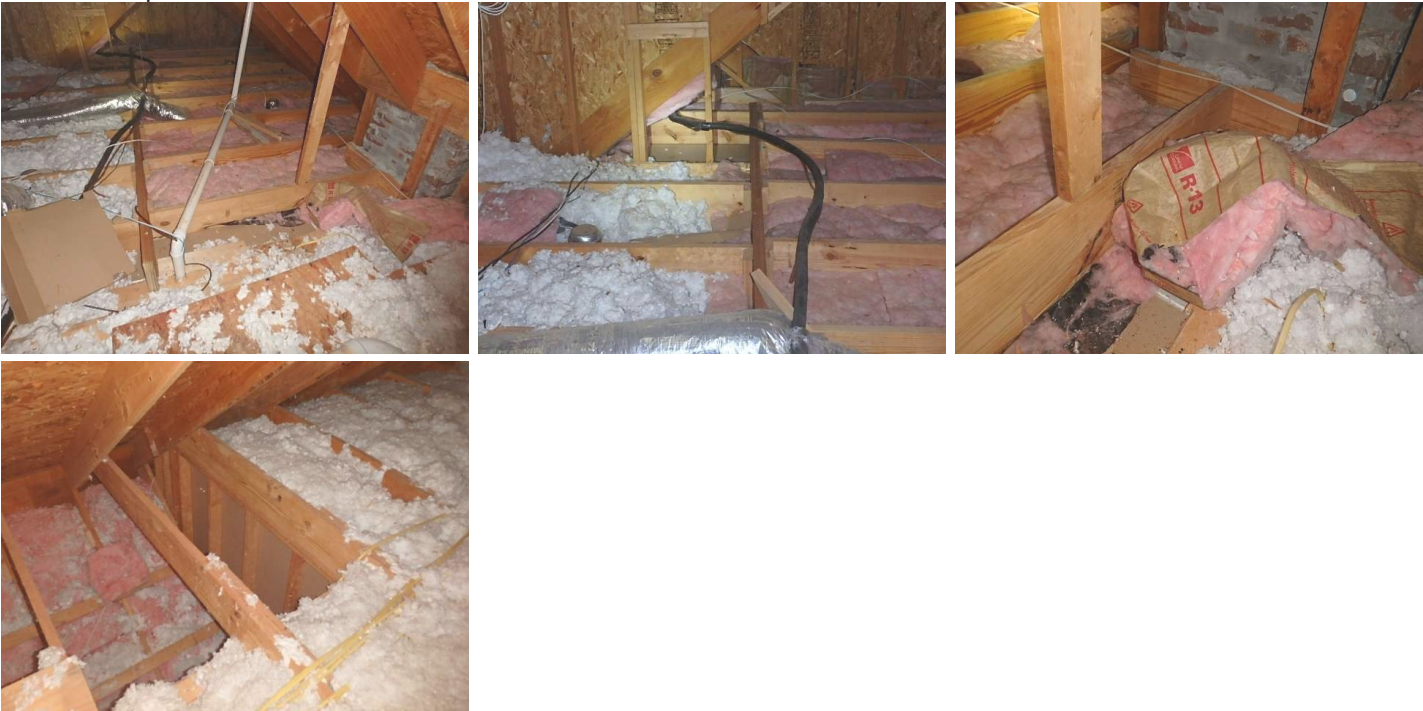
There are areas in the attic that are not properly insulated. This will reduce energy efficiency. I recommend adding or repairing the missing or weak insulation so that all areas are properly insulated for best efficiency. NOTE: current standard for attic insulation is R38.

Contact a qualified insulation contractor.

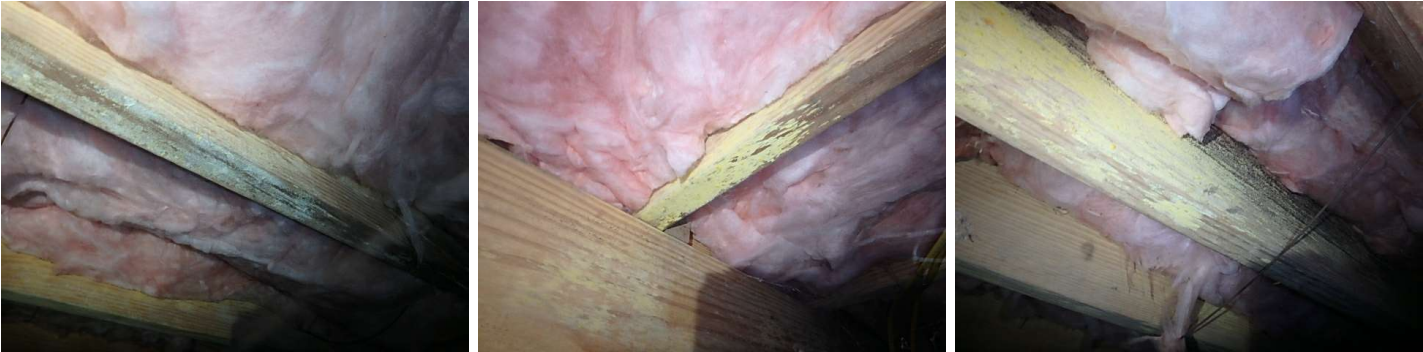
### EVIDENCE OF HUMID CONDITIONS

There is fungus on the framing at various locations in the crawlspace. This is an indication of elevated humidity / moisture levels. I recommend contacting an environmental contractor for further review and for possible methods of correction (removal and treatment of the fungus) and prevention (addressing the cause of elevated humidity levels).

Contact a qualified environmental contractor

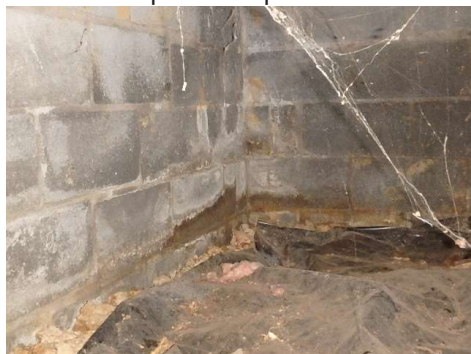
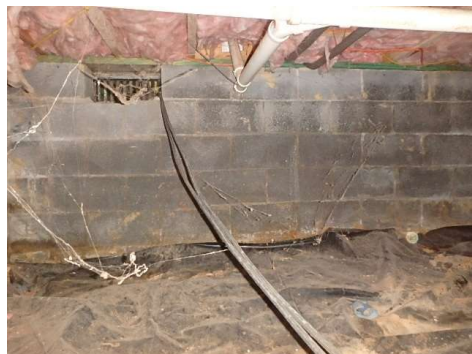
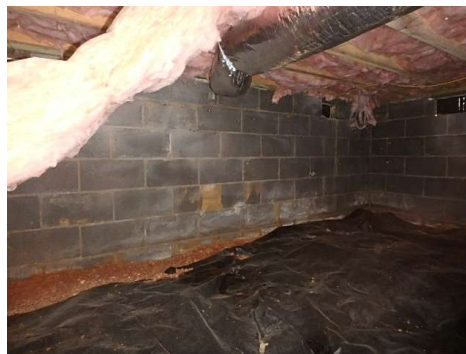
**MOISTURE ON FOUNDATION WALLS**

There were isolated areas in the crawlspace that were stained by moisture (some moisture was present during this inspection).

I recommend making necessary effort to divert water away from the foundation. Keep the gutters maintained so that water from the roof will be diverted away from the structure. Adjusting the soil in the flower beds could help to divert surface water away from the structure.

Contact a qualified professional.
